Windstorm Mitigation Inspection

308 PINE RIDGE CIRCLE GREEN ACRES FL 33463

Uniform Mitigation Verification Inspection Form

NAME: Pine Ridge III Condominium Association Inc			INSPECTION DATE: 12/29/2024		
ADDRESS: 308 PINE RIDGE CIRCLE GREEN ACRES FL 33463				COUNTY: PALM BEACH	
TEL:	YR BUILT: 1980	STORIES 2	AGENT:		
EMAIL:			POLICY#	Unit / Bldng

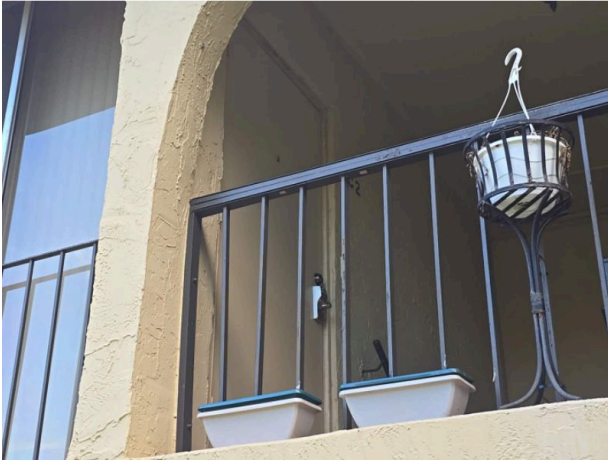
UNGLAZED OPENINGS

Multiple glazed and non glazed openings are non impact rated and unprotected or have unverified protection

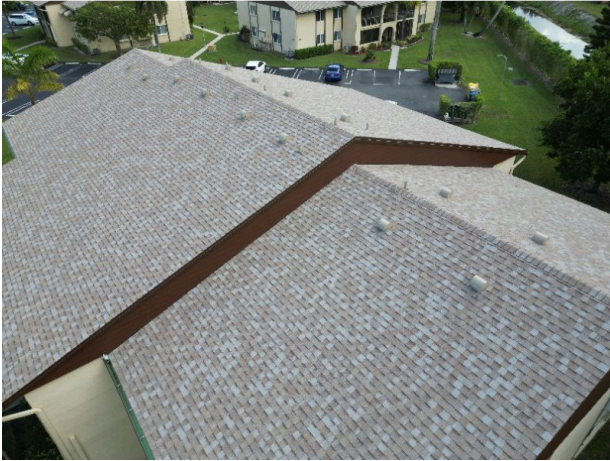
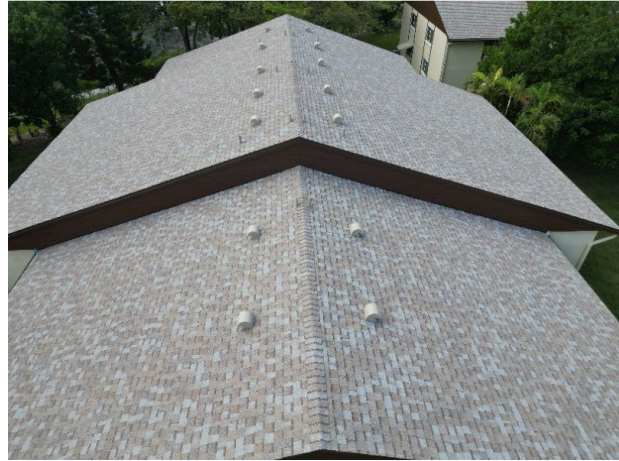
ROOF COVERING

1. Asphalt/Fiberglass Shingle 7/12/2024 2024-00002287 .
