Windstorm Mitigation Inspection

318 PINE RIDGE CIRCLE GREEN ACRES FL 33463

Uniform Mitigation Verification Inspection Form

NAME: Pine Ridge III Condominium Association Inc			INSPECTION DATE: 12/29/2024		
ADDRESS: 318 PINE RIDGE CIRCLE GREEN ACRES FL 33463				COUNTY: PALM BEACH	
TEL:	YR BUILT: 1979	STORIES 2	AGENT:		
EMAIL:			POLICY#	Unit / Bldng

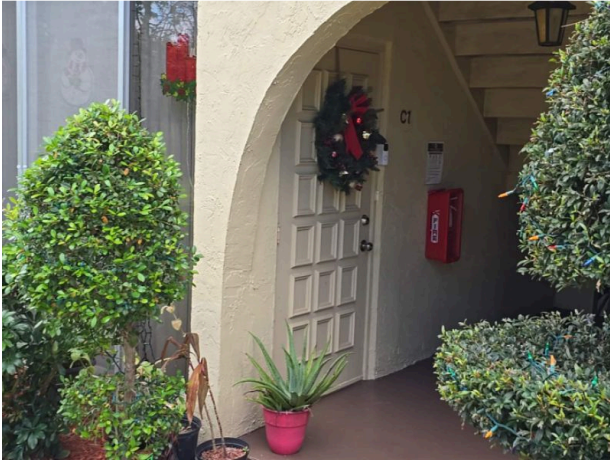
UNGLAZED OPENINGS

Multiple glazed and non glazed openings are non impact rated and unprotected or have unverified protection

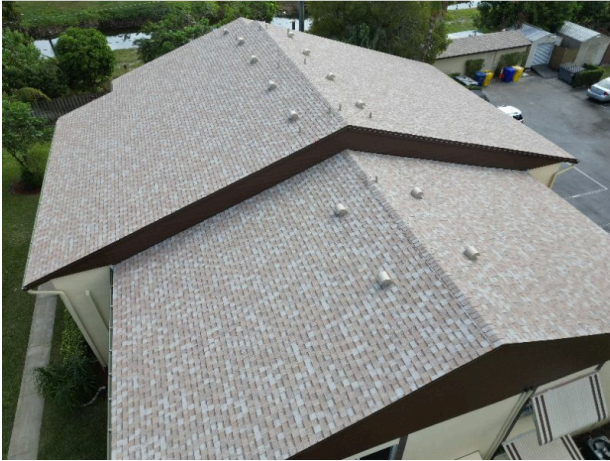
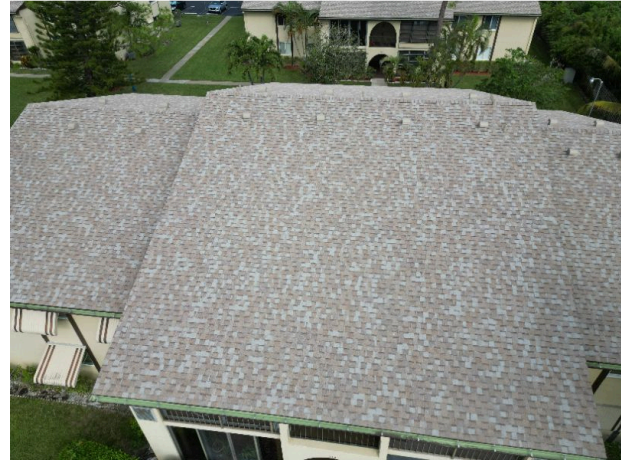
ROOF COVERING

1. Asphalt/Fiberglass Shingle 6/25/2024 2024-00002069 .
