Windstorm Mitigation Inspection

339 PINE RIDGE CIRCLE GREEN ACRES FL 33463

Uniform Mitigation Verification Inspection Form

NAME: Pine Ridge III Condominium Association Inc			INSPECTION DATE: 12/29/2024		
ADDRESS: 339 PINE RIDGE CIRCLE GREEN ACRES FL 33463				COUNTY: PALM BEACH	
TEL:	YR BUILT: 1980	STORIES 2	AGENT:		
EMAIL:			POLICY#	Unit / Bldng

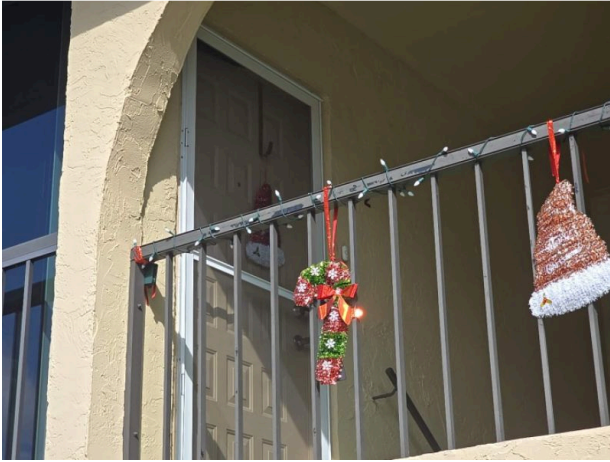
UNGLAZED OPENINGS

Multiple glazed and non glazed openings are non impact rated and unprotected or have unverified protection

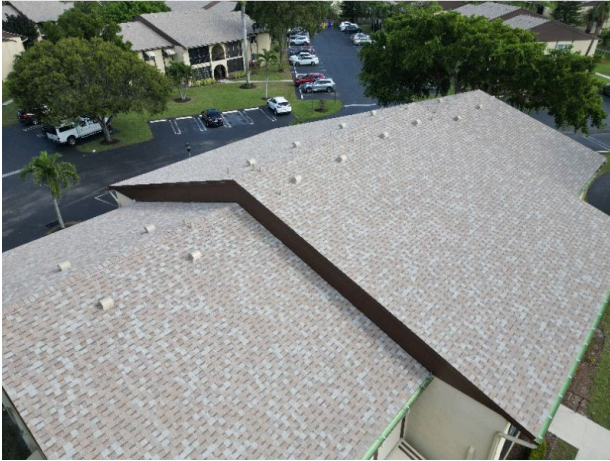
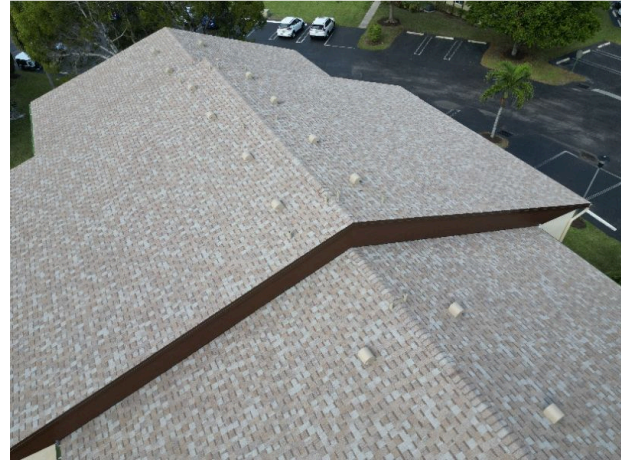
ROOF COVERING

1. Asphalt/Fiberglass Shingle 7/9/2024 2024-00002296 .
