## Windstorm Mitigation Inspection

**338 PINE RIDGE CIRCLE GREEN ACRES FL 33463**

Uniform Mitigation Verification Inspection Form

## OPENINGS REPORT / COMMENTS & OBSERVATIONS

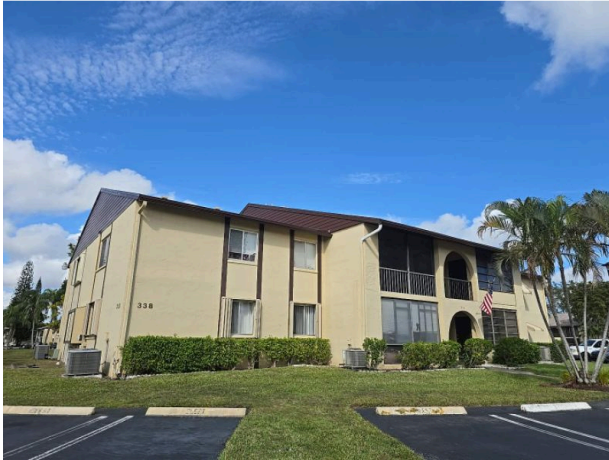
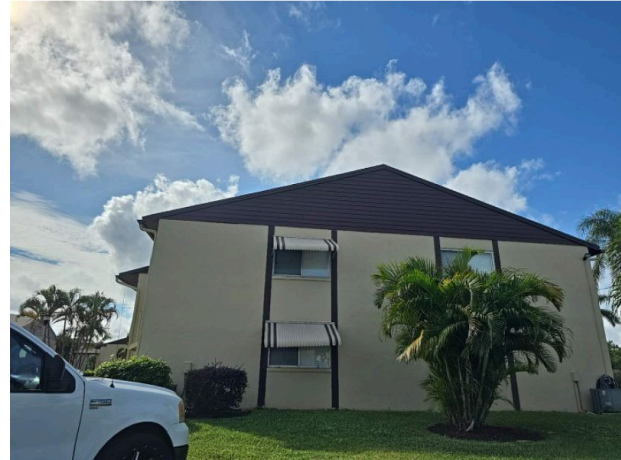
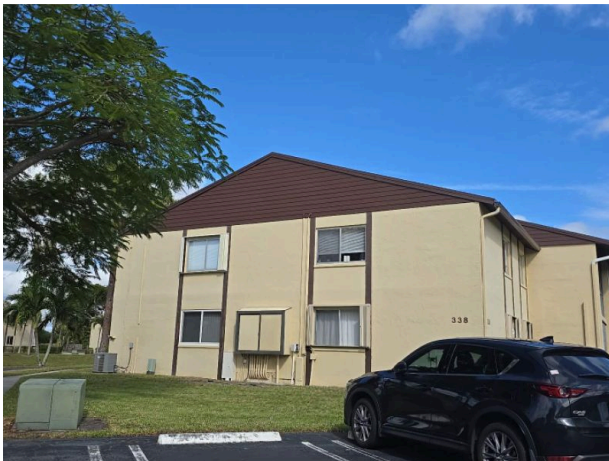
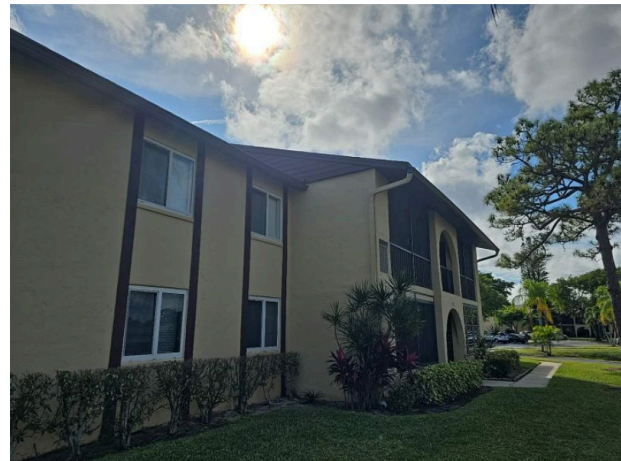
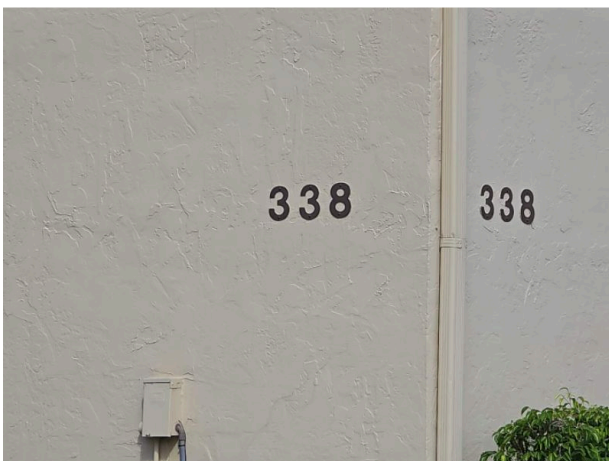
Elevation 1

**Multiple glazed and non glazed openings are non impact rated and unprotected or have unverified protection**

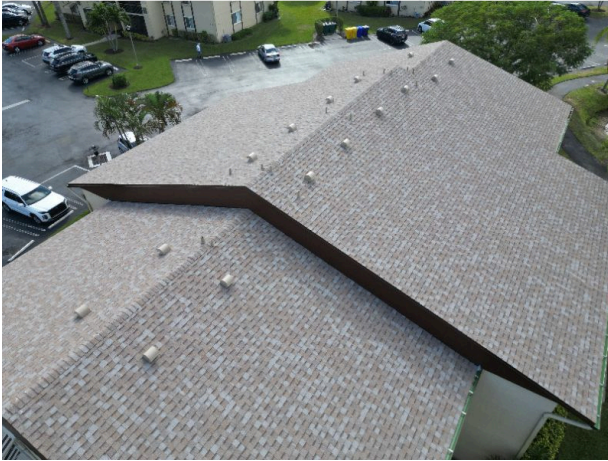
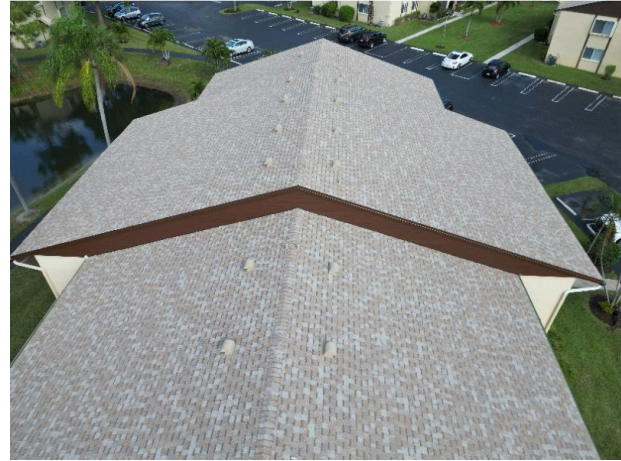
## ROOF COVERING

1. Asphalt/Fiberglass Shingle 7/9/2024 2024-00002295 .
