Windstorm Mitigation Inspection

330 PINE RIDGE CIRCLE GREEN ACRES FL 33463

Uniform Mitigation Verification Inspection Form

OPENINGS REPORT / COMMENTS & OBSERVATIONS

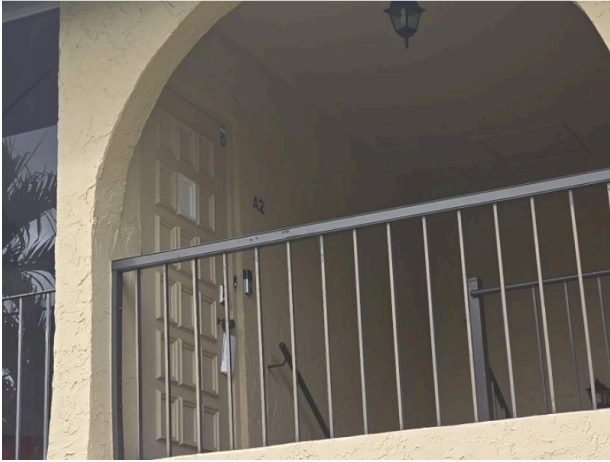
UNGLAZED OPENINGS

Multiple glazed and non glazed openings are non impact rated and unprotected or have unverified protection

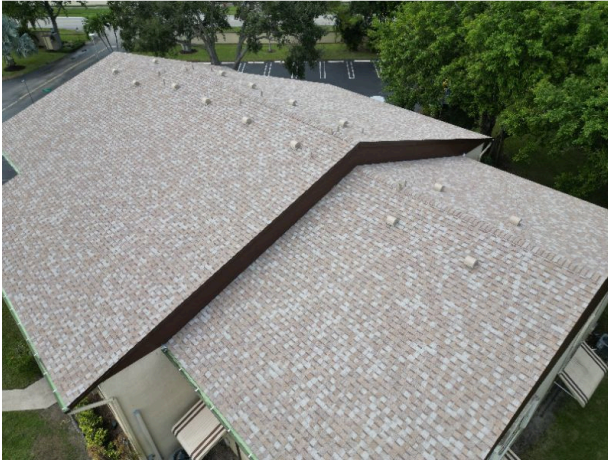
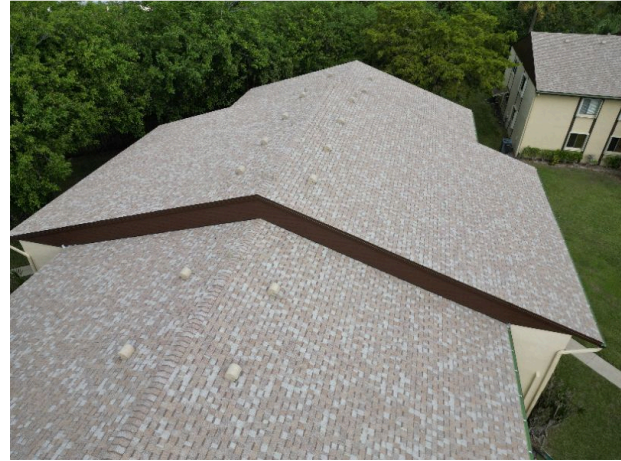
ROOF COVERING

1. Asphalt/Fiberglass Shingle 5/23/2024 2024-00001917 .
