## Windstorm Mitigation Inspection

**312 PINE RIDGE CIRCLE GREEN ACRES FL 33463**

Uniform Mitigation Verification Inspection Form

## OPENINGS REPORT / COMMENTS & OBSERVATIONS

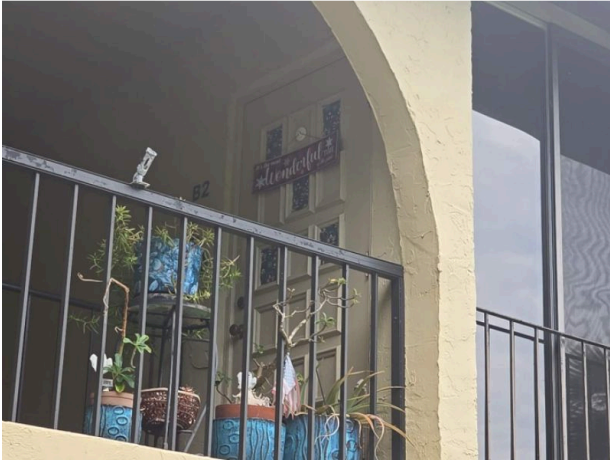
### UNGLAZED OPENINGS

**Multiple glazed and non glazed openings are non impact rated and unprotected or have unverified protection**

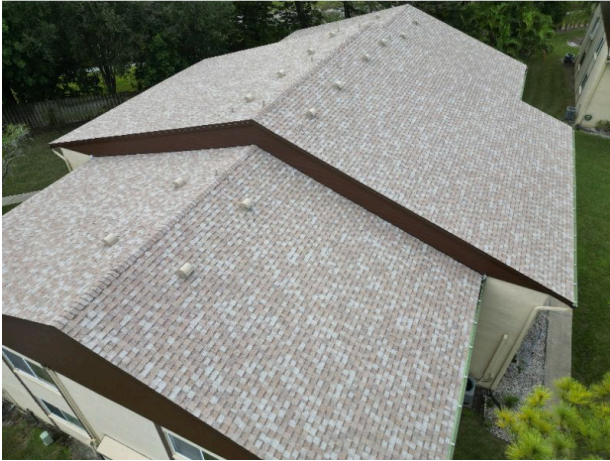
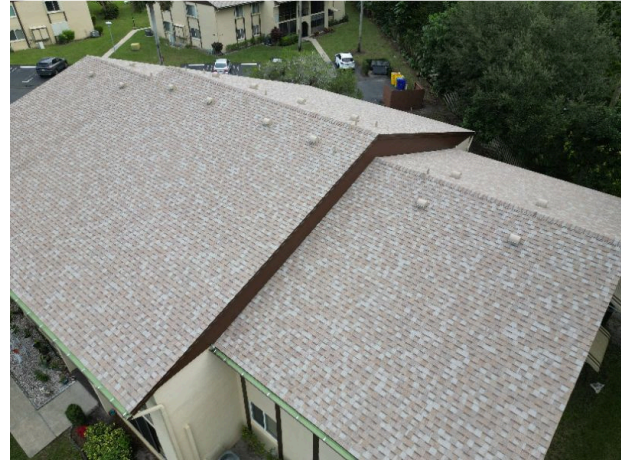
## ROOF COVERING

1. Asphalt/Fiberglass Shingle 6/25/2024 2024-00002063 .
