Windstorm Mitigation Inspection

305 PINE RIDGE CIRCLE GREEN ACRES FL 33463

Uniform Mitigation Verification Inspection Form

OPENINGS REPORT / COMMENTS & OBSERVATIONS

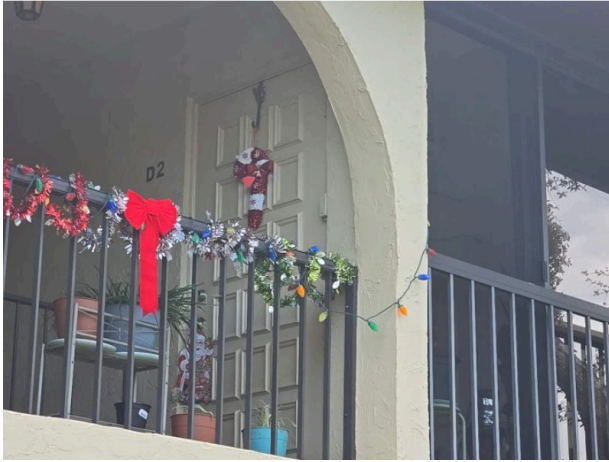
UNGLAZED OPENINGS

Multiple glazed and non glazed openings are non impact rated and unprotected or have unverified protection
