## Windstorm Mitigation Inspection

**341 PINE RIDGE CIRCLE GREEN ACRES FL 33463**

Uniform Mitigation Verification Inspection Form

## OPENINGS REPORT / COMMENTS & OBSERVATIONS

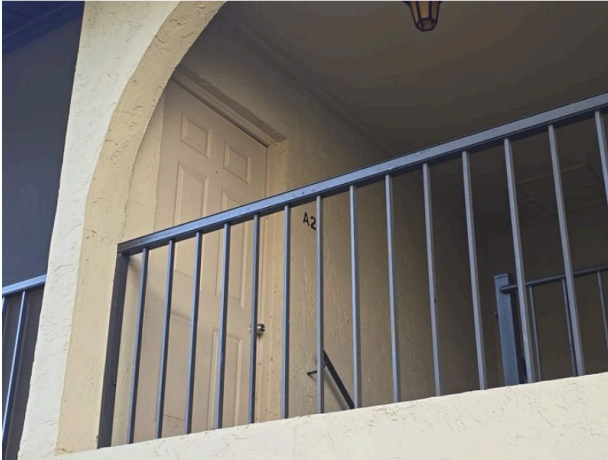
### UNGLAZED OPENINGS

**Multiple glazed and non glazed openings are non impact rated and unprotected or have unverified protection**

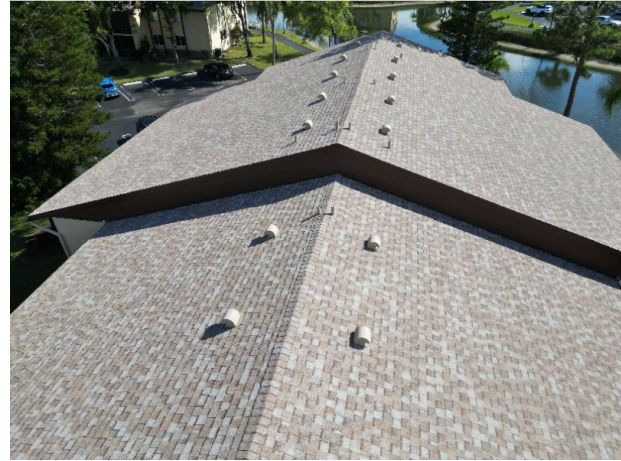
## ROOF COVERING

1. Asphalt/Fiberglass Shingle 7/12/2024 2024-00002298 .
