Windstorm Mitigation Inspection

Uniform Mitigation Verification Inspection Form

NAME: Pine Ridge III Condominium Association Inc			INSPECTION DATE: 12/29/2024		
ADDRESS: 333 PINE RIDGE CIRCLE GREEN ACRES FL 33463				COUNTY: PALM BEACH	
TEL:	YR BUILT: 1983	STORIES 2	AGENT:		
EMAIL:			POLICY#	Unit / Bldng

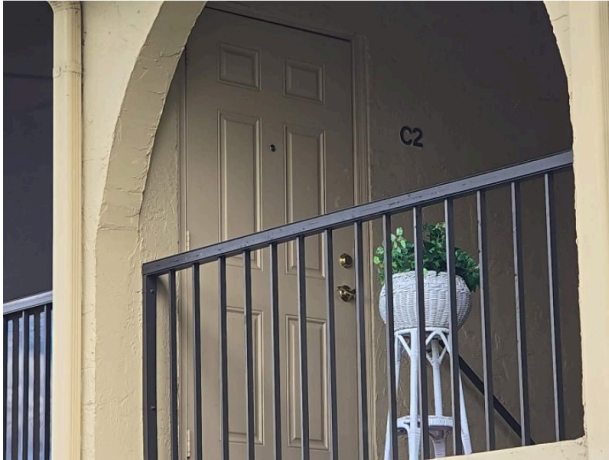
UNGLAZED OPENINGS

Multiple glazed and non glazed openings are non impact rated and unprotected or have unverified protection

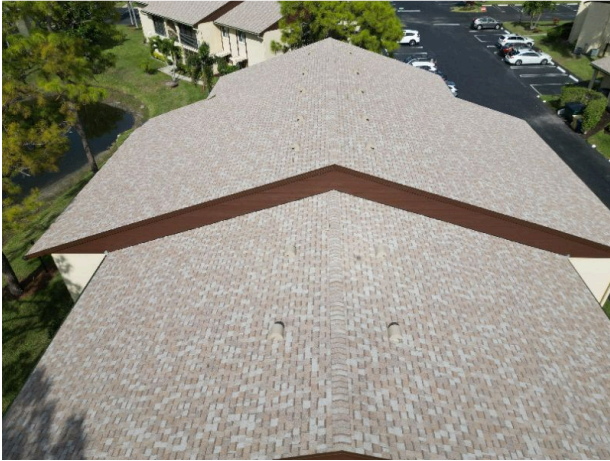
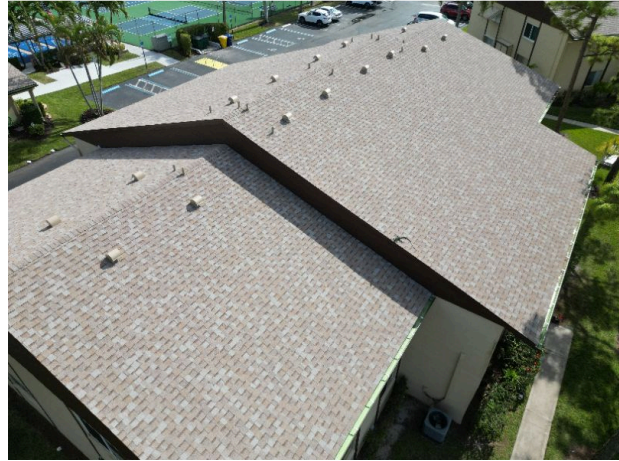
ROOF COVERING

1. Asphalt/Fiberglass Shingle 7/12/2024 2024-00002290 .
