Windstorm Mitigation Inspection

313 PINE RIDGE CIRCLE GREEN ACRES FL 33463

Uniform Mitigation Verification Inspection Form

OPENINGS REPORT / COMMENTS & OBSERVATIONS

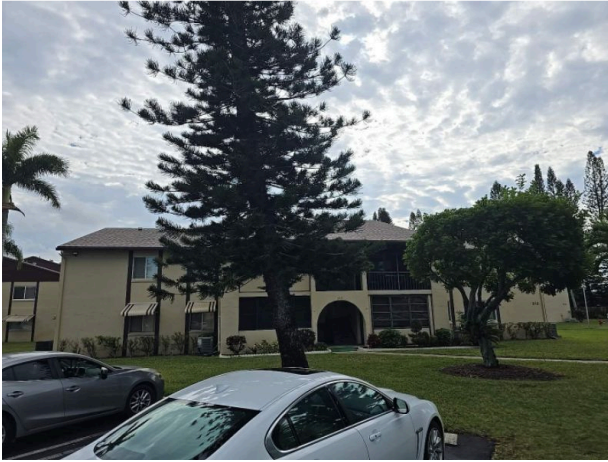
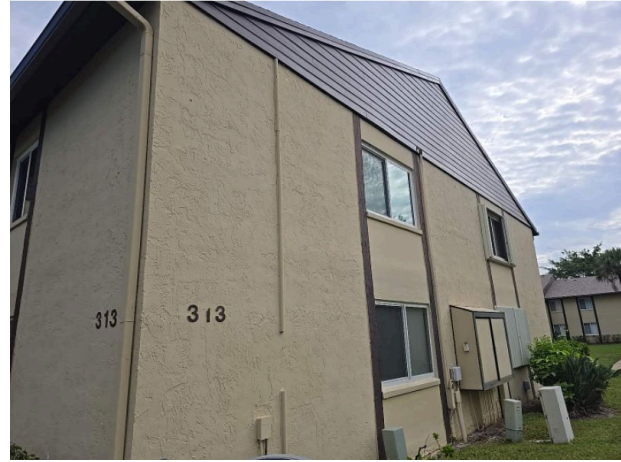
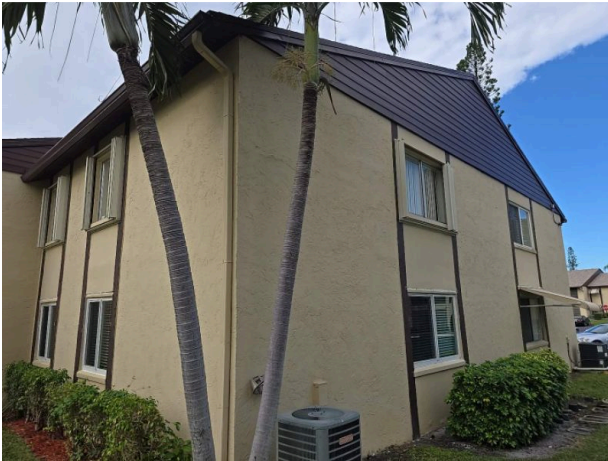
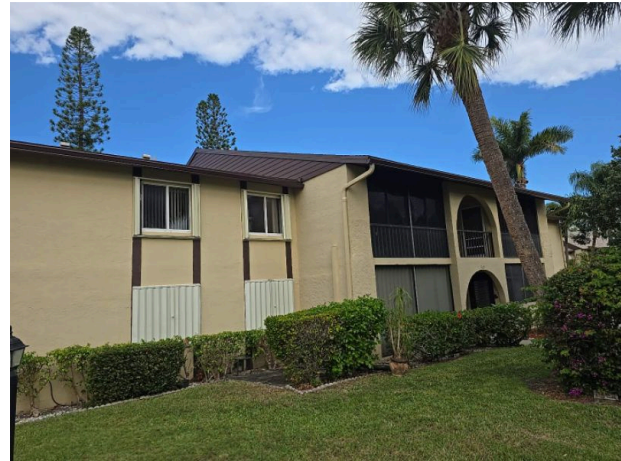
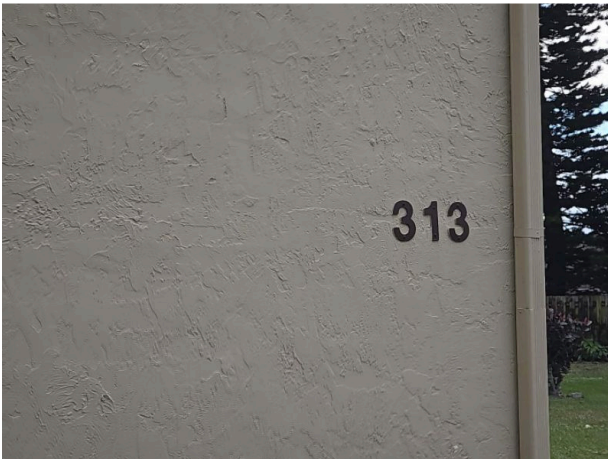
Elevation 1

Multiple glazed and non glazed openings are non impact rated and unprotected or have unverified protection

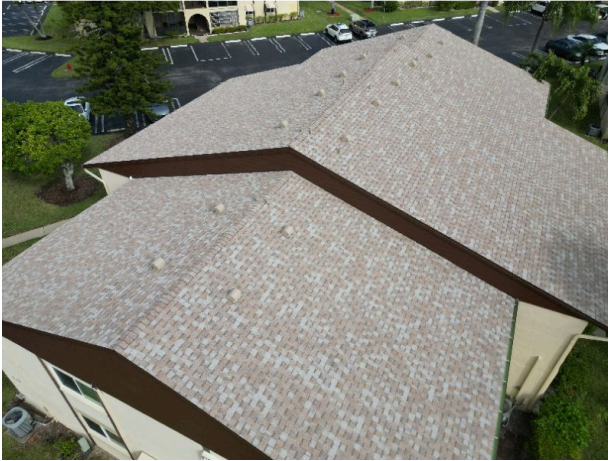
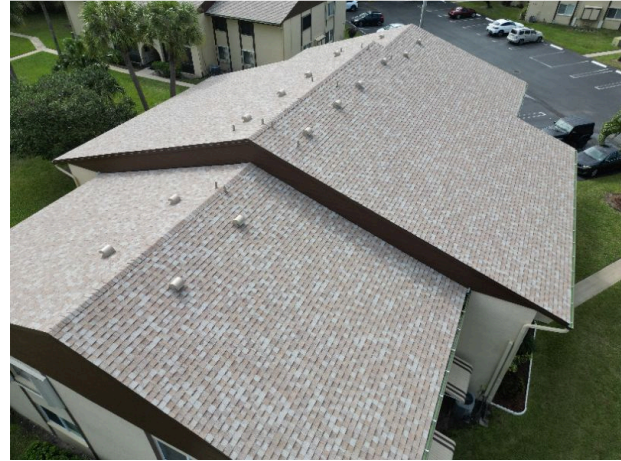
ROOF COVERING

2.1 Roof Covering Type:	Permit Application Date	FBC / MDC Product Approval #	Year of Original Installation or Replacement	No Information Provided for Compliance
<input checked="" type="checkbox"/> 1. Asphalt/Fiberglass Shingle	6/25/2024	2024-00002064	.	
<input type="checkbox"/> 2. Concrete/Clay Tile				
<input type="checkbox"/> 3. Metal				
<input type="checkbox"/> 4. Built-up				
<input type="checkbox"/> 5. Membrane				
<input type="checkbox"/> 6. Other
