Windstorm Mitigation Inspection

306 PINE RIDGE CIRCLE GREEN ACRES FL 33463

Uniform Mitigation Verification Inspection Form

NAME: Pine Ridge III Condominium Association Inc			INSPECTION DATE: 12/29/2024		
ADDRESS: 306 PINE RIDGE CIRCLE GREEN ACRES FL 33463				COUNTY: PALM BEACH	
TEL:	YR BUILT: 1980	STORIES 2	AGENT:		
EMAIL:			POLICY#	Unit / Bldng

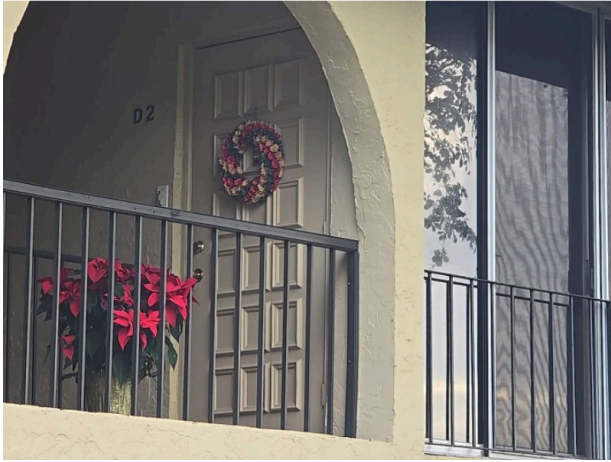
UNGLAZED OPENINGS

Multiple glazed and non glazed openings are non impact rated and unprotected or have unverified protection

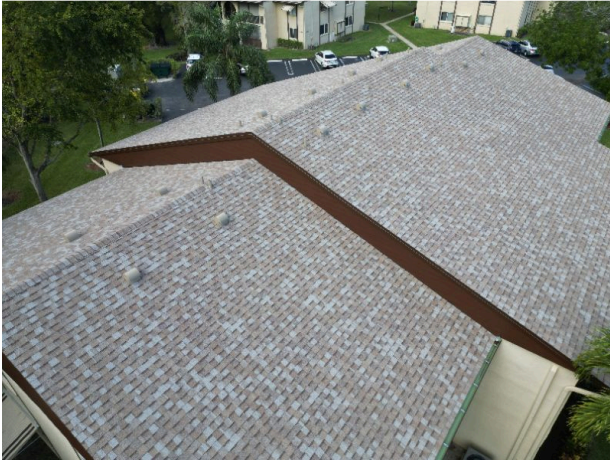
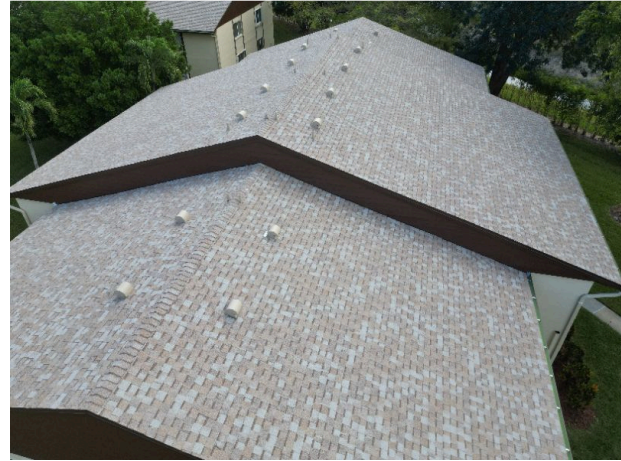
ROOF COVERING

1. Asphalt/Fiberglass Shingle 7/12/2024 2024-00002285 .
