## Windstorm Mitigation Inspection

**316 PINE RIDGE CIRCLE GREEN ACRES FL 33463**

Uniform Mitigation Verification Inspection Form

## OPENINGS REPORT / COMMENTS & OBSERVATIONS

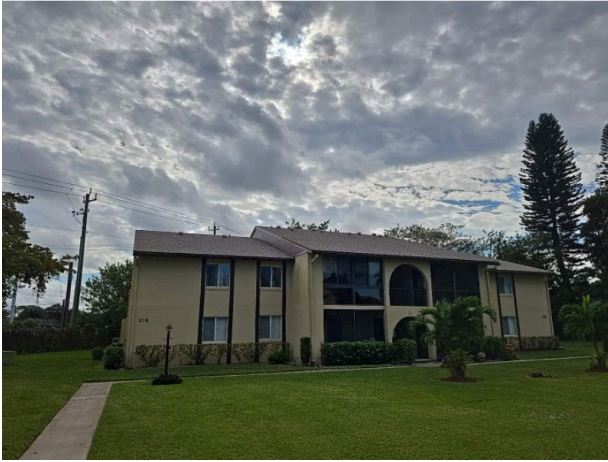
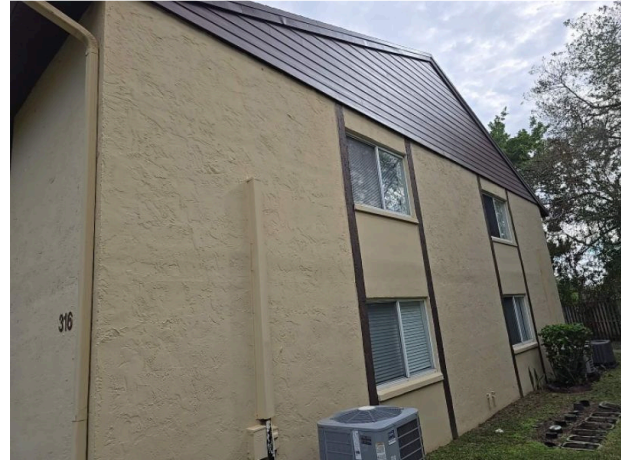
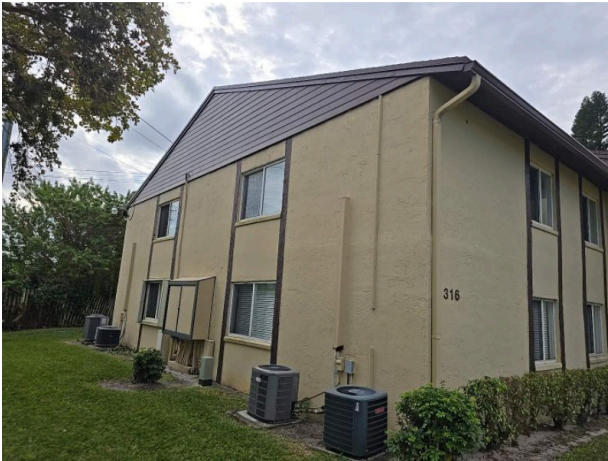
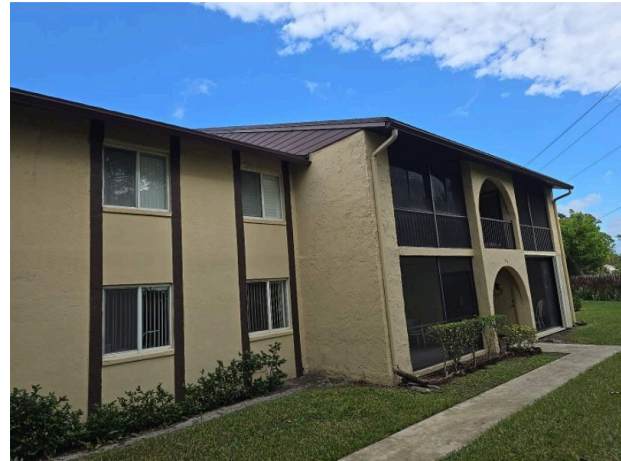
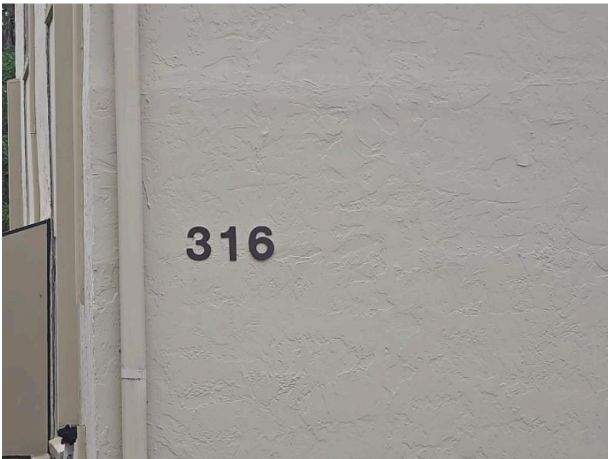
Elevation 1

**Multiple glazed and non glazed openings are non impact rated and unprotected or have unverified protection**

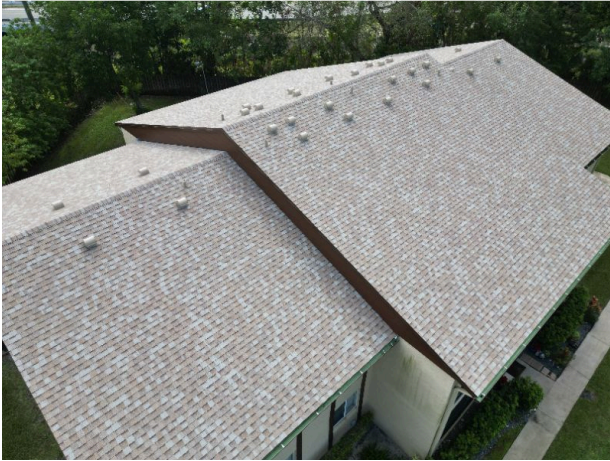
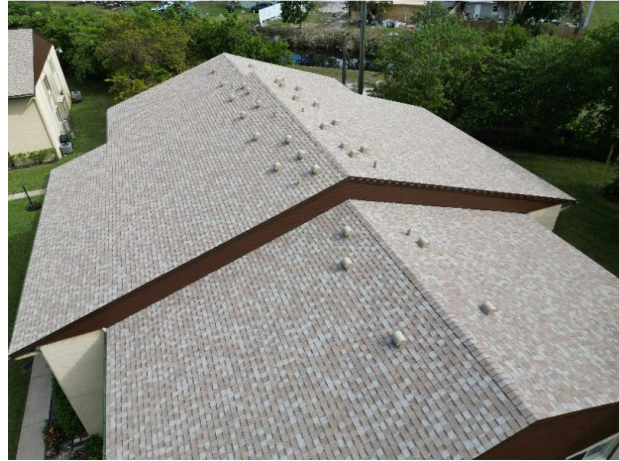
## ROOF COVERING

1. Asphalt/Fiberglass Shingle 6/25/2024 2024-00002067 .
