## Windstorm Mitigation Inspection

**320 PINE RIDGE CIRCLE GREEN ACRES FL 33463**

Uniform Mitigation Verification Inspection Form

## OPENINGS REPORT / COMMENTS & OBSERVATIONS

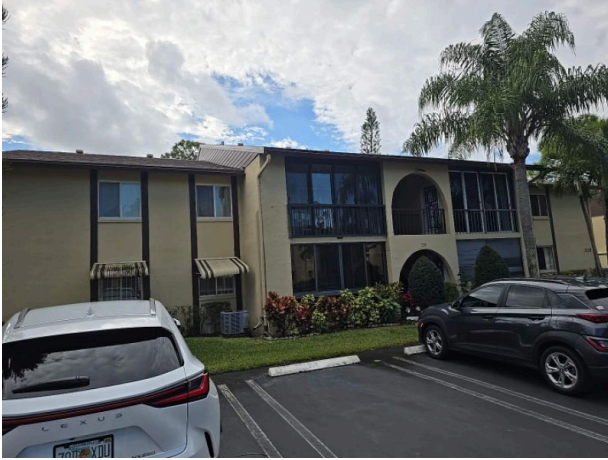
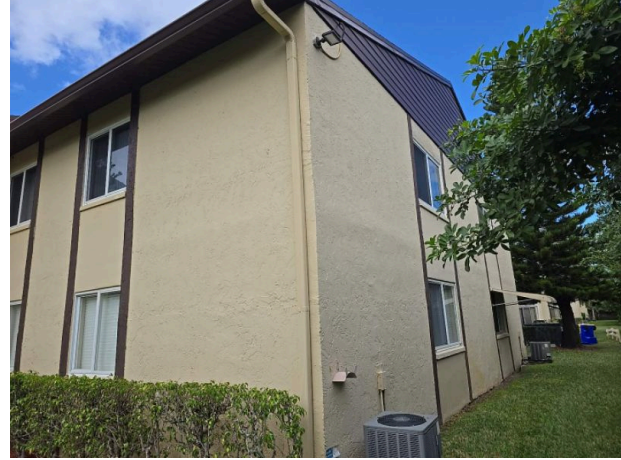
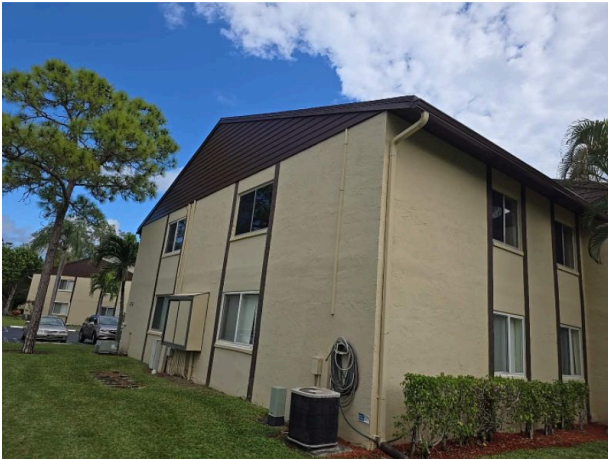
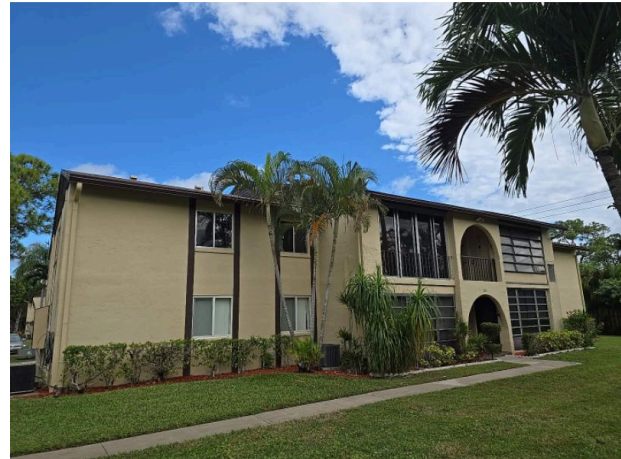
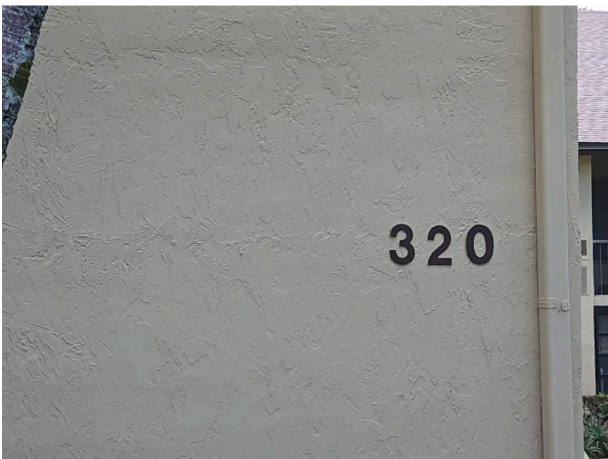
Elevation 1

**Multiple glazed and non glazed openings are non impact rated and unprotected or have unverified protection**

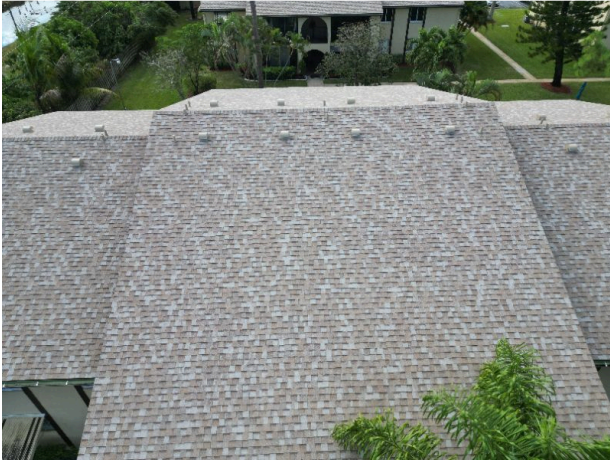
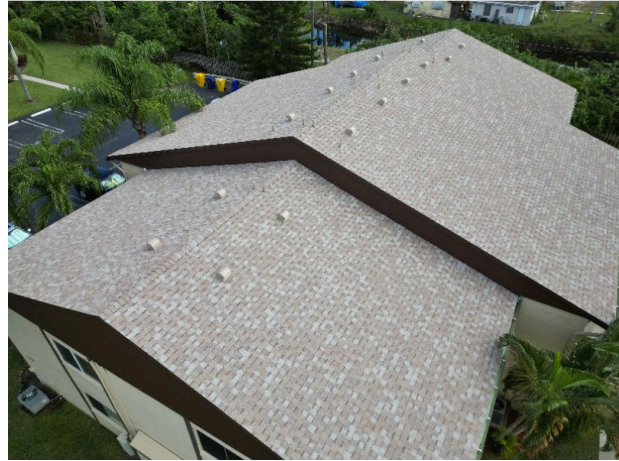
## ROOF COVERING

1. Asphalt/Fiberglass Shingle 6/25/2024 2024-00002071 .
