## Windstorm Mitigation Inspection

**321 PINE RIDGE CIRCLE GREEN ACRES FL 33463**

Uniform Mitigation Verification Inspection Form

## OPENINGS REPORT / COMMENTS & OBSERVATIONS

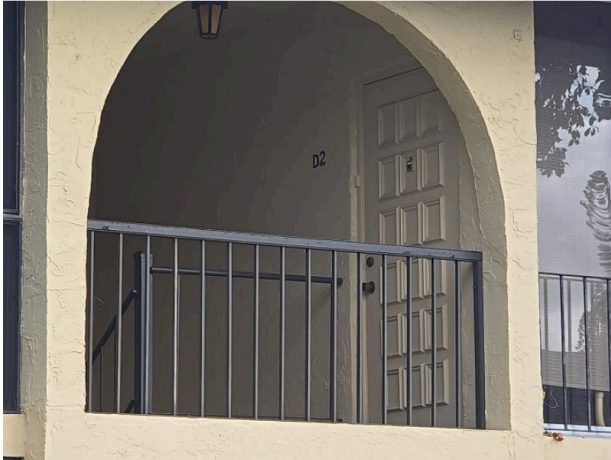
### UNGLAZED OPENINGS

**Multiple glazed and non glazed openings are non impact rated and unprotected or have unverified protection**

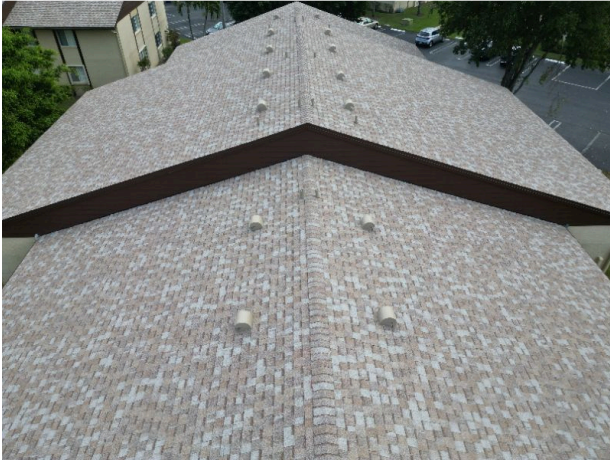
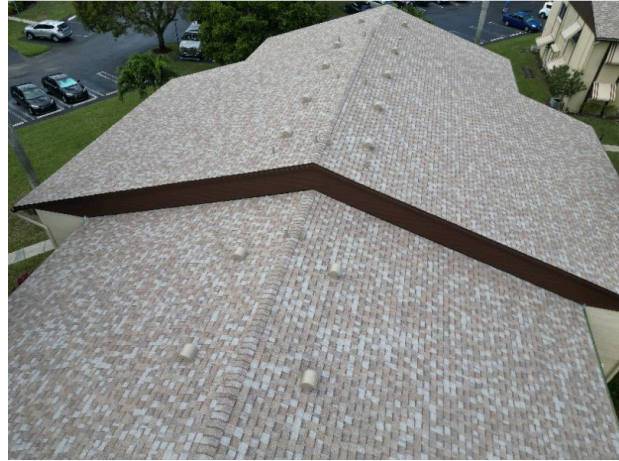
## ROOF COVERING

2.1 Roof Covering Type:	Permit Application Date	FBC / MDC Product Approval #	Year of Original Installation or Replacement	No Information Provided for Compliance
<input checked="" type="checkbox"/> 1. Asphalt/Fiberglass Shingle	5/23/2024	2024-00001909	.	
<input type="checkbox"/> 2. Concrete/Clay Tile				
<input type="checkbox"/> 3. Metal				
<input type="checkbox"/> 4. Built-up				
<input type="checkbox"/> 5. Membrane				
<input type="checkbox"/> 6. Other
