Windstorm Mitigation Inspection

310 PINE RIDGE CIRCLE GREEN ACRES FL 33463

Uniform Mitigation Verification Inspection Form

NAME: Pine Ridge III Condominium Association Inc			INSPECTION DATE: 12/29/2024		
ADDRESS: 310 PINE RIDGE CIRCLE GREEN ACRES FL 33463				COUNTY: PALM BEACH	
TEL:	YR BUILT: 1980	STORIES 2	AGENT:		
EMAIL:			POLICY#	Unit / Bldng

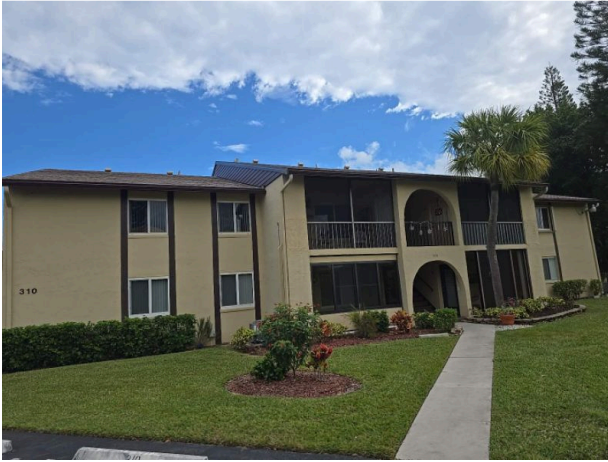
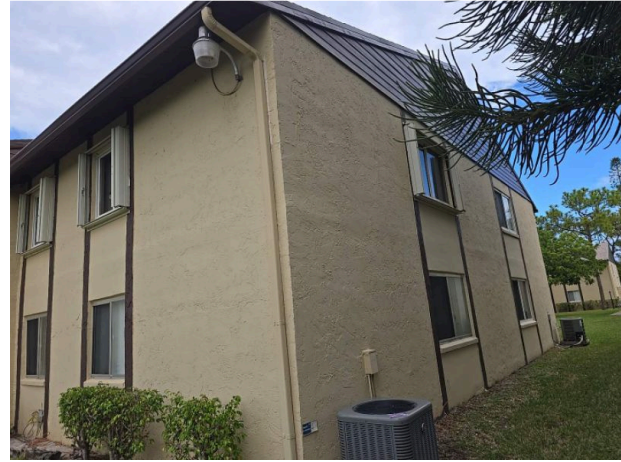
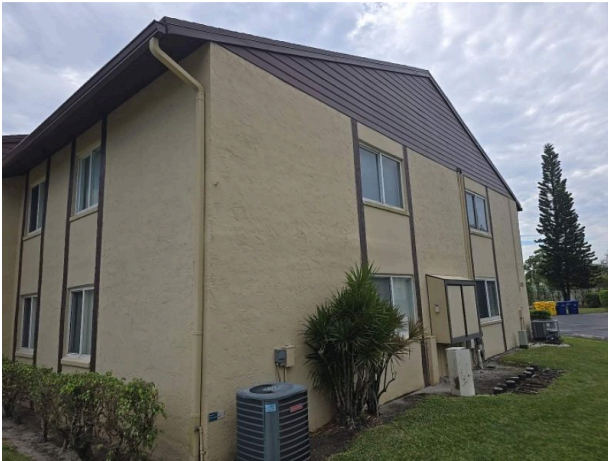
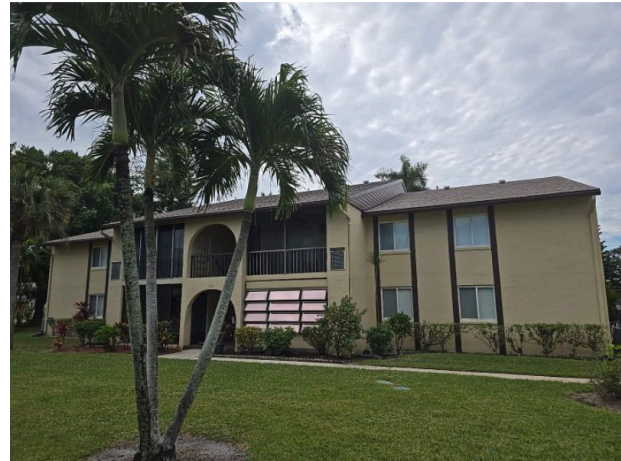
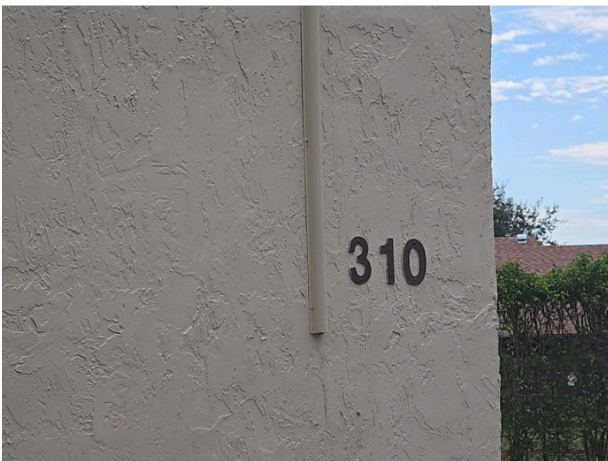
Elevation 1

Multiple glazed and non glazed openings are non impact rated and unprotected or have unverified protection

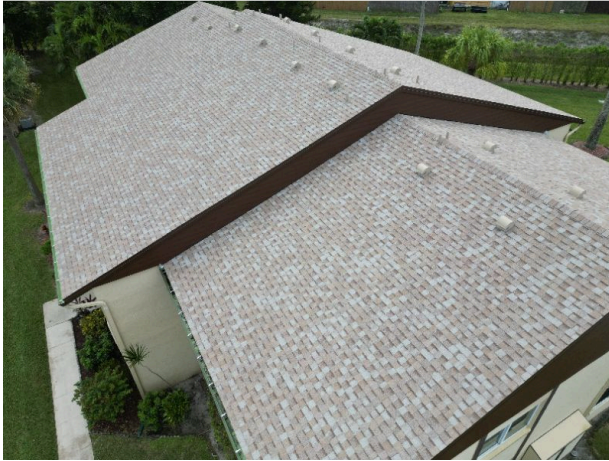
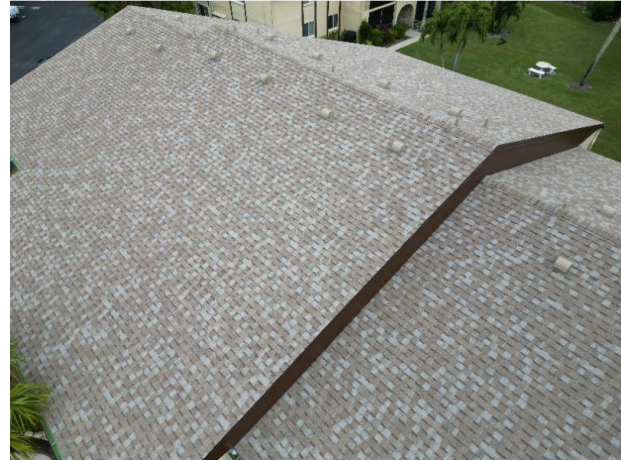
ROOF COVERING

2.1 Roof Covering Type:	Permit Application Date	FBC / MDC Product Approval #	Year of Original Installation or Replacement	No Information Provided for Compliance
<input checked="" type="checkbox"/> 1. Asphalt/Fiberglass Shingle	6/25/2024	2024-00002061	.	
<input type="checkbox"/> 2. Concrete/Clay Tile				
<input type="checkbox"/> 3. Metal				
<input type="checkbox"/> 4. Built-up				
<input type="checkbox"/> 5. Membrane				
<input type="checkbox"/> 6. Other
