Fleet Inspections

Windstorm Mitigation Inspection

329 PINE RIDGE CIRCLE GREEN ACRES FL 33463

Uniform Mitigation Verification Inspection Form

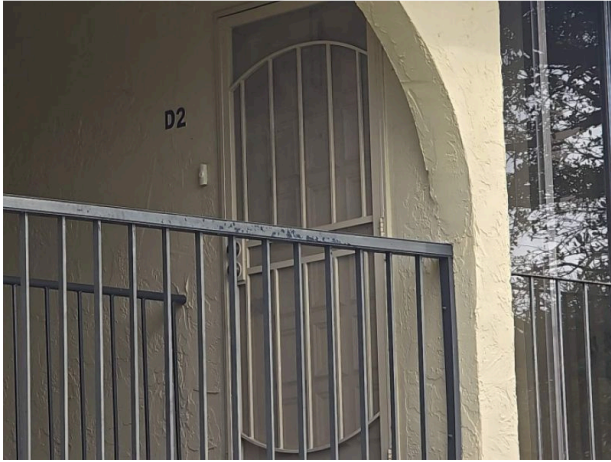
UNGLAZED OPENINGS

Multiple glazed and non glazed openings are non impact rated and unprotected or have unverified protection

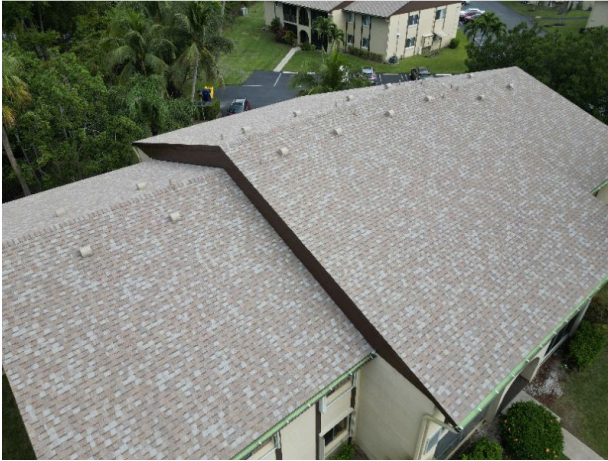
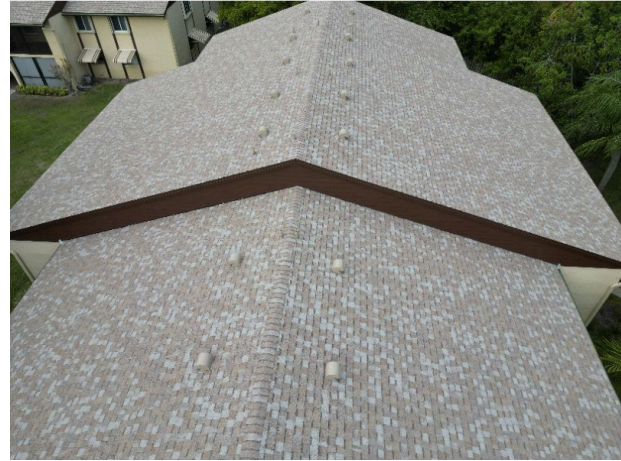
ROOF COVERING

1. Asphalt/Fiberglass Shingle 5/23/2024 2024-00001916 .
