Windstorm Mitigation Inspection

331 PINE RIDGE CIRCLE GREEN ACRES FL 33463

Uniform Mitigation Verification Inspection Form

NAME: Pine Ridge III Condominium Association Inc			INSPECTION DATE: 12/29/2024		
ADDRESS: 331 PINE RIDGE CIRCLE GREEN ACRES FL 33463				COUNTY: PALM BEACH	
TEL:	YR BUILT: 1979	STORIES 2	AGENT:		
EMAIL:			POLICY#	Unit / Bldng

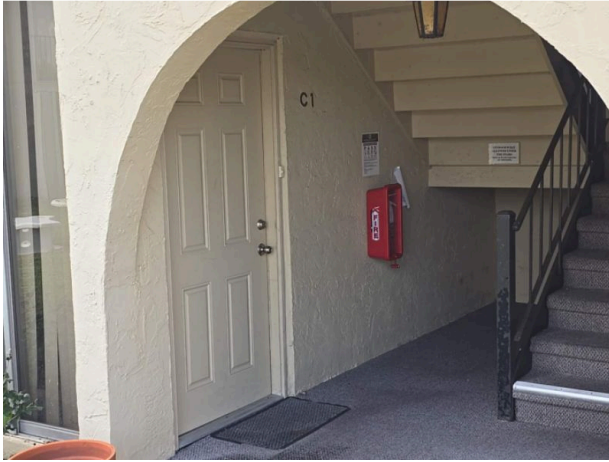
UNGLAZED OPENINGS

Multiple glazed and non glazed openings are non impact rated and unprotected or have unverified protection

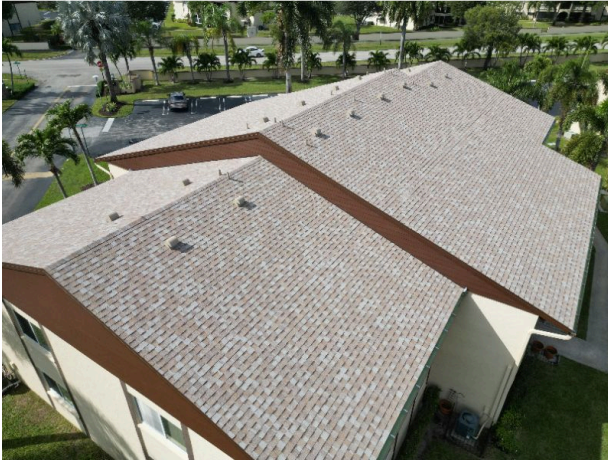
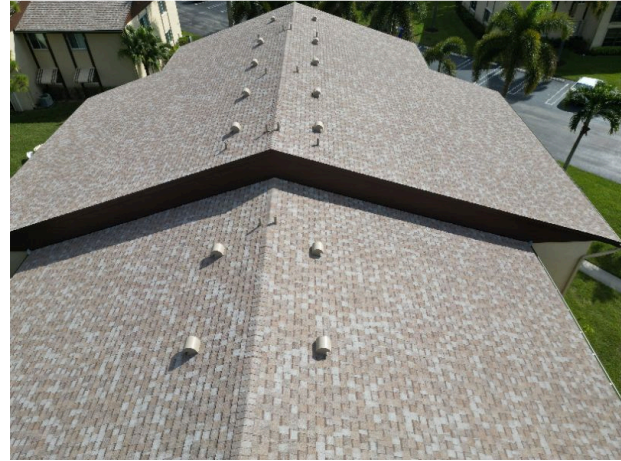
ROOF COVERING

2.1 Roof Covering Type:	Permit Application Date	FBC / MDC Product Approval #	Year of Original Installation or Replacement	No Information Provided for Compliance
<input checked="" type="checkbox"/> 1. Asphalt/Fiberglass Shingle	7/12/2024	2024-00002288	.	
<input type="checkbox"/> 2. Concrete/Clay Tile				
<input type="checkbox"/> 3. Metal				
<input type="checkbox"/> 4. Built-up				
<input type="checkbox"/> 5. Membrane				
<input type="checkbox"/> 6. Other
