## Windstorm Mitigation Inspection

**304 PINE RIDGE CIRCLE GREEN ACRES FL 33463**

Uniform Mitigation Verification Inspection Form

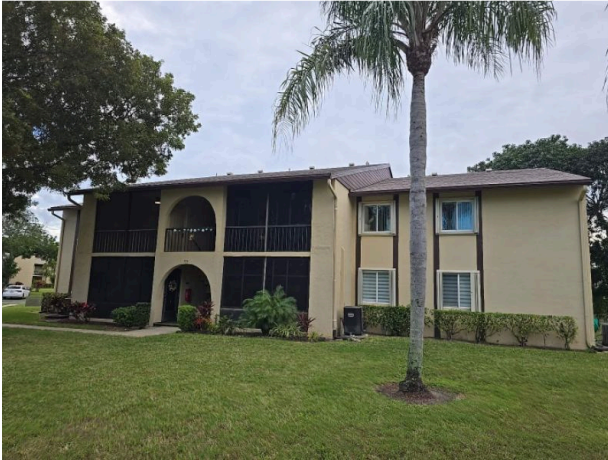
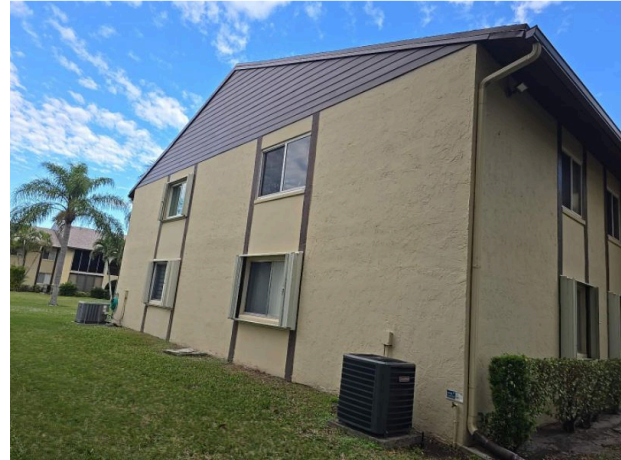
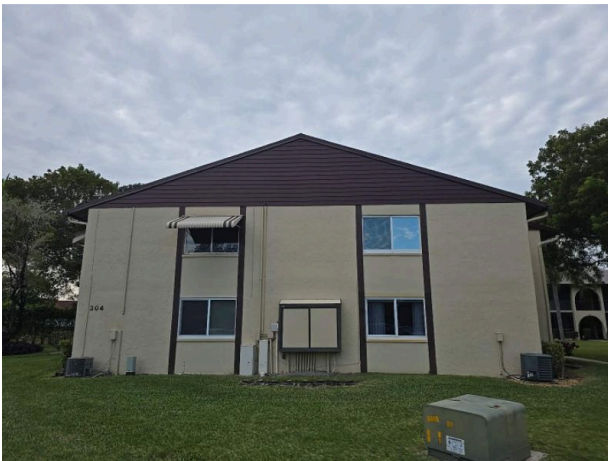
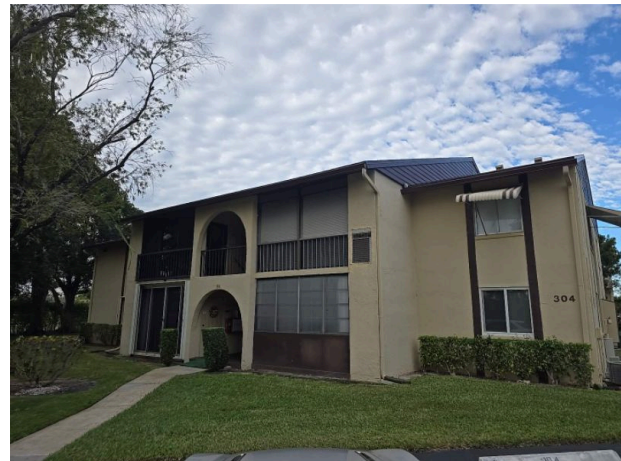
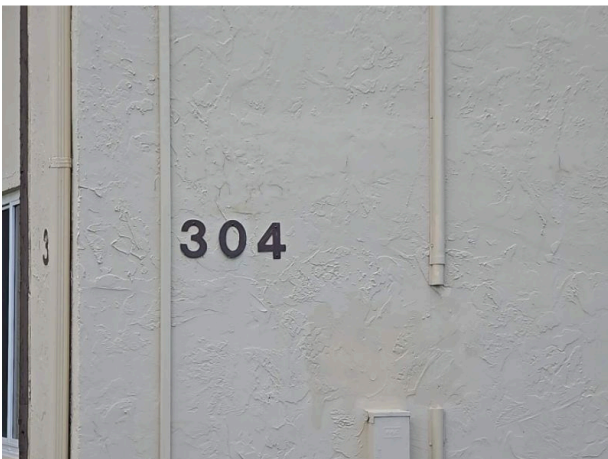
Elevation 1

**Multiple glazed and non glazed openings are non impact rated and unprotected or have unverified protection**

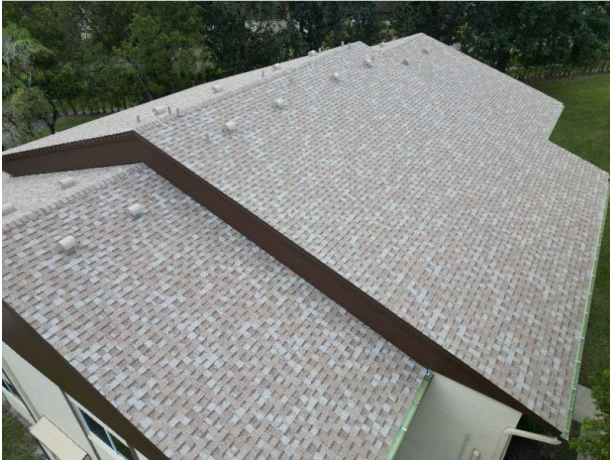
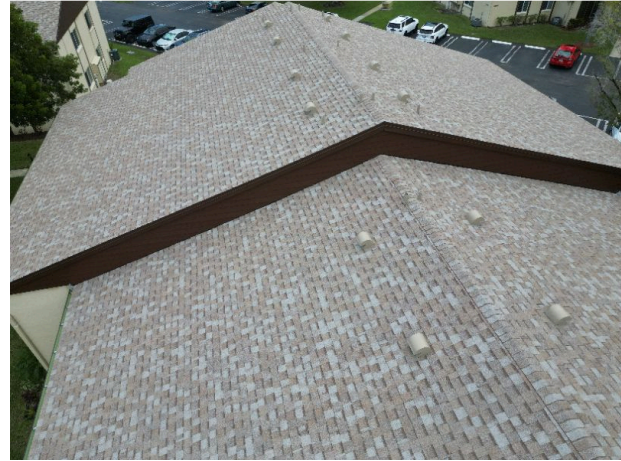
## ROOF COVERING

1. Asphalt/Fiberglass Shingle 7/12/2024 2024-00002283 .
