Windstorm Mitigation Inspection

323 PINE RIDGE CIRCLE GREEN ACRES FL 33463

Uniform Mitigation Verification Inspection Form

NAME: Pine Ridge III Condominium Association Inc			INSPECTION DATE: 12/29/2024		
ADDRESS: 323 PINE RIDGE CIRCLE GREEN ACRES FL 33463				COUNTY: PALM BEACH	
TEL:	YR BUILT: 1980	STORIES 2	AGENT:		
EMAIL:			POLICY#	Unit / Bldng

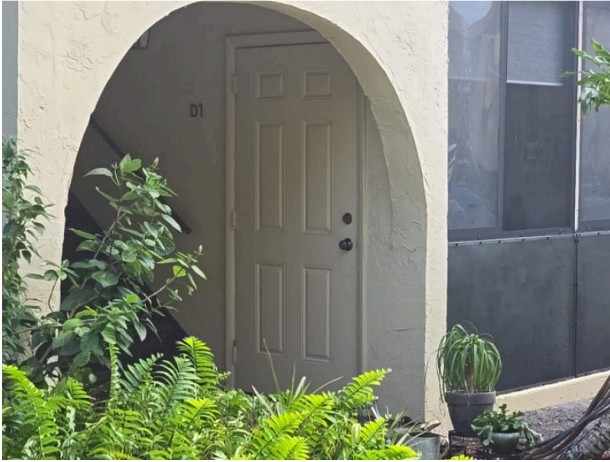
UNGLAZED OPENINGS

Multiple glazed and non glazed openings are non impact rated and unprotected or have unverified protection

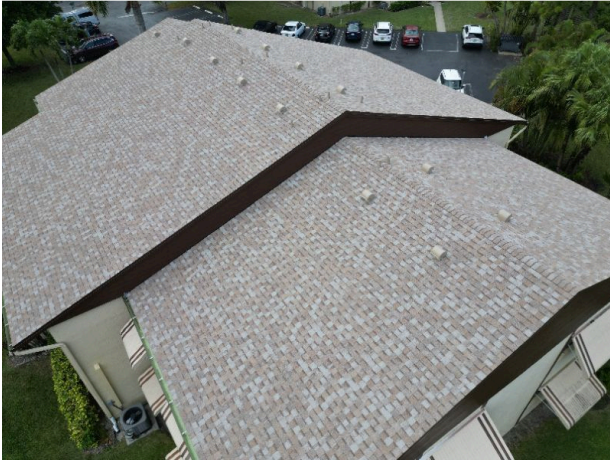
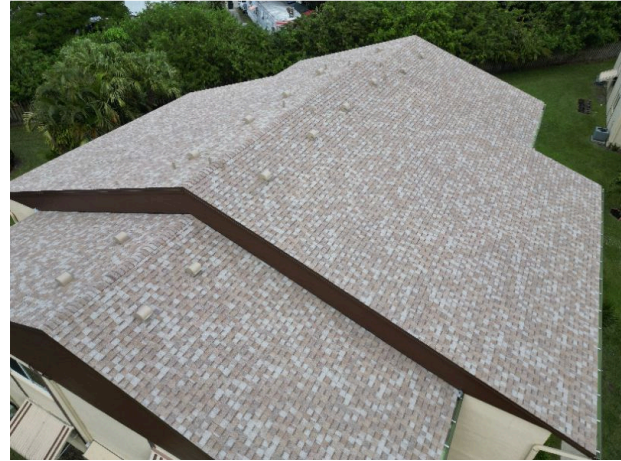
ROOF COVERING

1. Asphalt/Fiberglass Shingle 5/21/2024 2024-00001794 .
