Windstorm Mitigation Inspection

311 PINE RIDGE CIRCLE GREEN ACRES FL 33463

Uniform Mitigation Verification Inspection Form

NAME: Pine Ridge III Condominium Association Inc			INSPECTION DATE: 12/29/2024		
ADDRESS: 311 PINE RIDGE CIRCLE GREEN ACRES FL 33463				COUNTY: PALM BEACH	
TEL:	YR BUILT: 1980	STORIES 2	AGENT:		
EMAIL:			POLICY#	Unit / Bldng

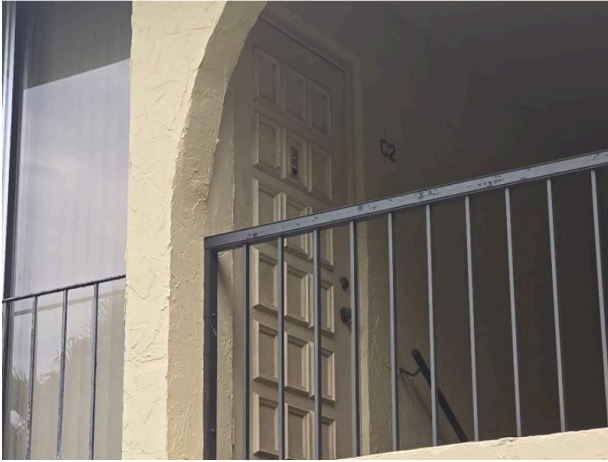
UNGLAZED OPENINGS

Multiple glazed and non glazed openings are non impact rated and unprotected or have unverified protection

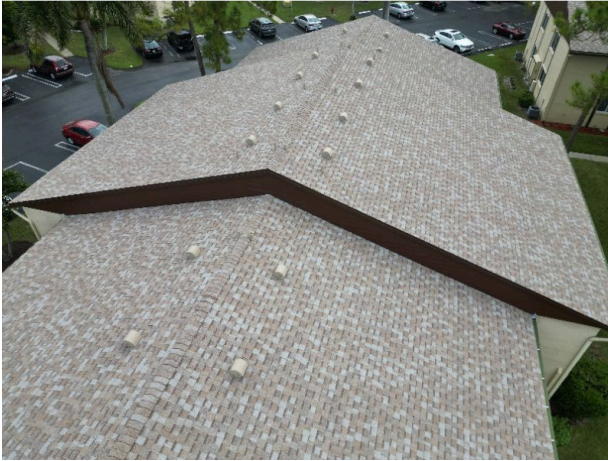
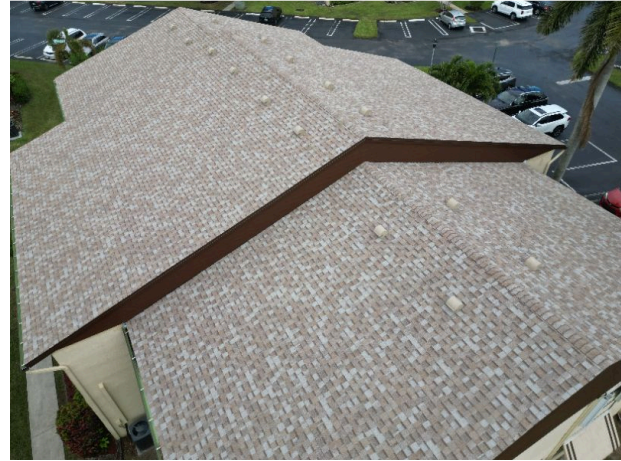
ROOF COVERING

1. Asphalt/Fiberglass Shingle 6/25/2024 2024-00002062 .
