Windstorm Mitigation Inspection

314 PINE RIDGE CIRCLE GREEN ACRES FL 33463

Uniform Mitigation Verification Inspection Form

NAME: Pine Ridge III Condominium Association Inc			INSPECTION DATE: 12/29/2024		
ADDRESS: 314 PINE RIDGE CIRCLE GREEN ACRES FL 33463				COUNTY: PALM BEACH	
TEL:	YR BUILT: 1980	STORIES 2	AGENT:		
EMAIL:			POLICY#	Unit / Bldng

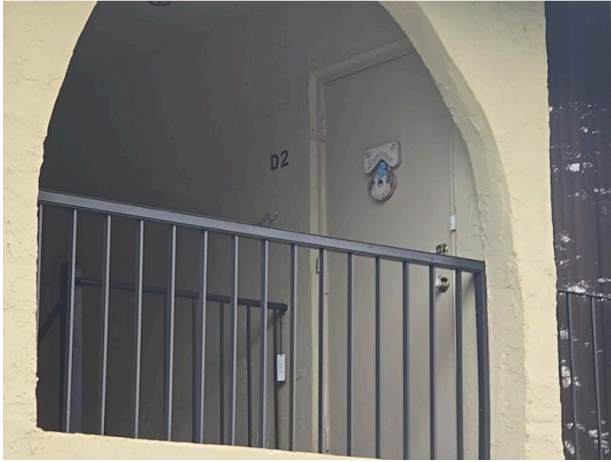
UNGLAZED OPENINGS

Multiple glazed and non glazed openings are non impact rated and unprotected or have unverified protection

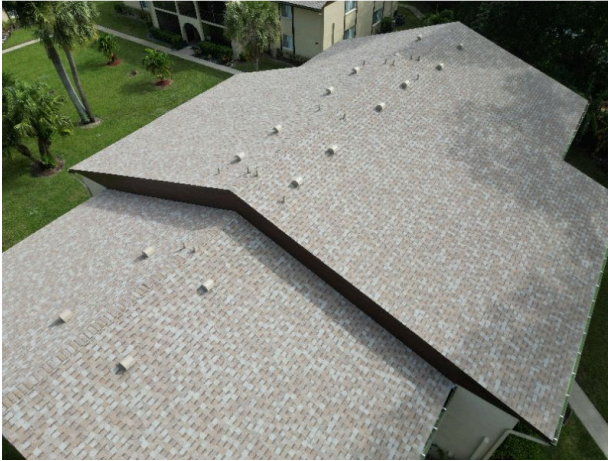
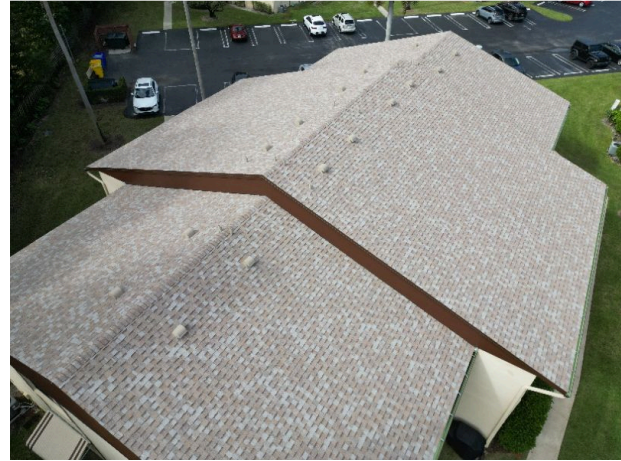
ROOF COVERING

1. Asphalt/Fiberglass Shingle 6/25/2024 2024-00002065 .
